Triumph TR7 TR8 Clock Repair

Greg Bober, Copyright 17 March 2012, Rev 2.7 (originally written 4 July 2005)

Abstract

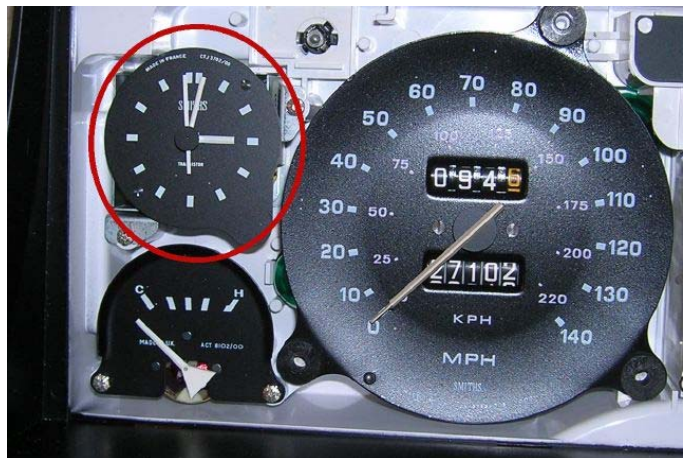
Picture 1: The TR7/TR8 clock in instrument cluster
